LAKE GILMAN DAM

NJ 00431

PHASE 1 INSPECTION REPORT NATIONAL DAM SAFETY PROGRAM

August, 1979

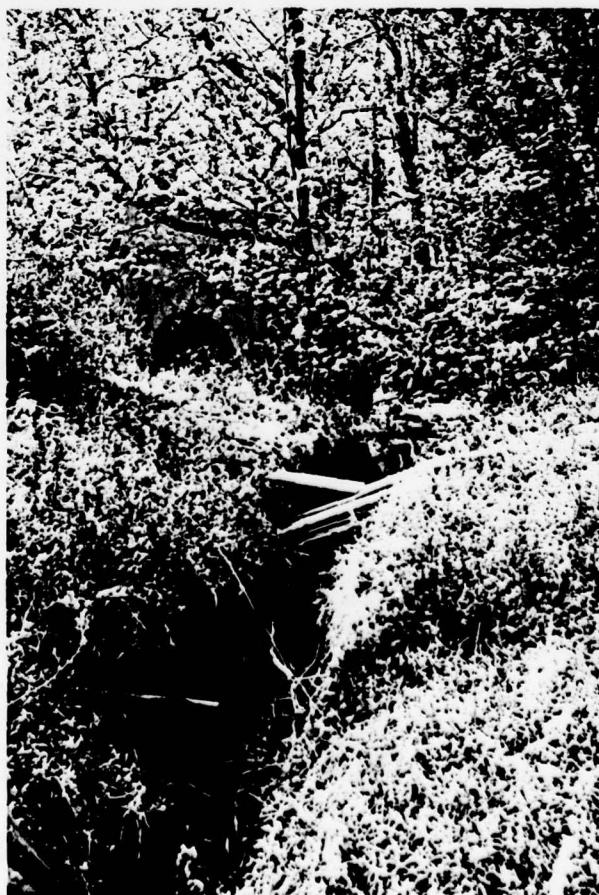
View of Ditch at Right Downstream Toe of Dam

The roadway embankment which forms the earth portion of the dam was found to be in a stable condition. The low point of the sag vertical curve of the road profile is located to the right of the spillway and it was noted that any flows over the crest would be concentrated in this area. Proceeding towards each abutment zone, the crest rises approximately two feet. The roadway is asphalt paved and is in good condition although the shoulders are eroded and sloughed off near the edges. The sideslopes are irregular and there is severe erosion at the right downstream wingwall of the culvert. There is a substantial amount of broken concrete riprap placed along the upstream face and a low timber bulkhead constructed near the left end of the dam along the upstream shoulder. There are several 2 to 8 inch trees and brush with a chainlink fence installed across the dam (see appended photographs). There are several larger trees on the downstream slopes. Much of the sideslope erosion is due to run-off from the roadway pavement but an 18-inch drain has been placed at the left downstream wingwall to prevent further erosion in this area. The downstream slopes are not well maintained. Some seepage was observed in a ditch which is ten feet beyond the downstream toe to the right of the culvert.
